THE USUAL SUSPECTS

Irregular Steer Tire Wear Patterns

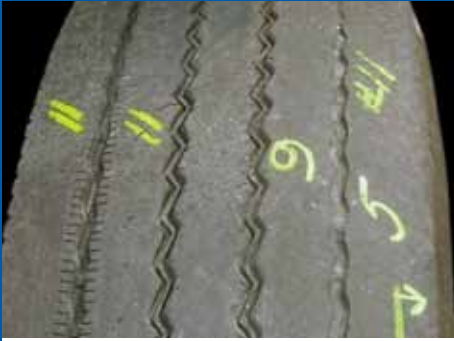
One Sided Wear

Appearance	Wear increasing from one side to the other.
Probable Cause	Out of alignment specification parameters (camber, toe, axle parallelism).
Corrective Action	Check alignment and inspect for worn parts.
Tire Disposition	Continue to run until minimum tread depth is reached.

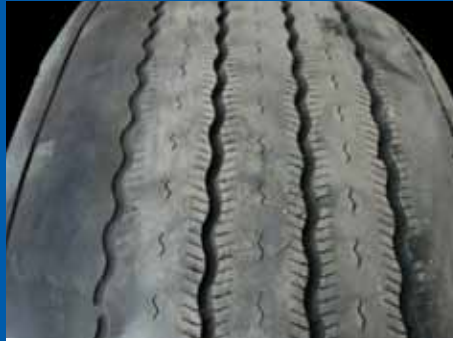
Shoulder Step Wear

Appearance	Partial or full depression of the inside or outside shoulder tread rib.
Probable Cause	This condition is common on radial tires in slow wearing operations.
Corrective Action	None
Tire Disposition	Continue to run or rotate.

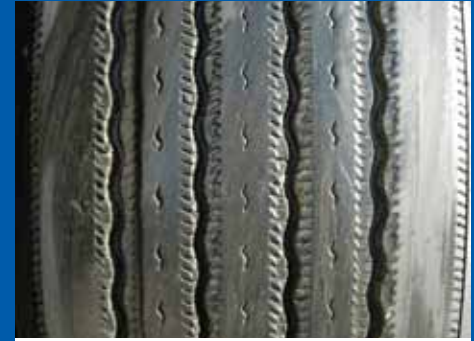
Erosion/River Wear

Appearance	Circumferential worn area situated on the sides of the tread ribs.
Probable Cause	Condition most commonly occurs on slow wearing radial tires in steer or trailer position (free rolling).
Corrective Action	None
Tire Disposition	Continue to run.

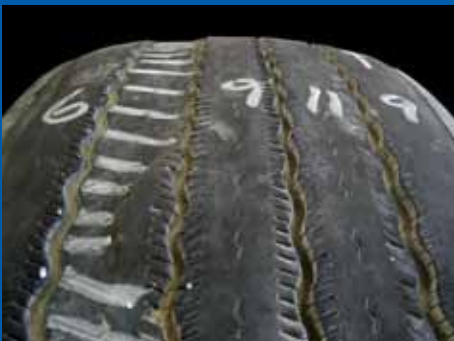
Depression Wear (Intermediate)

Appearance	One or more interior ribs (not center) depressed more than adjacent ribs.
Probable Cause	Incorrect air pressure, worn mechanical part, or non-uniformity such as mismatch.
Corrective Action	Check air pressure and mechanical issues.
Tire Disposition	Rotate or retread.

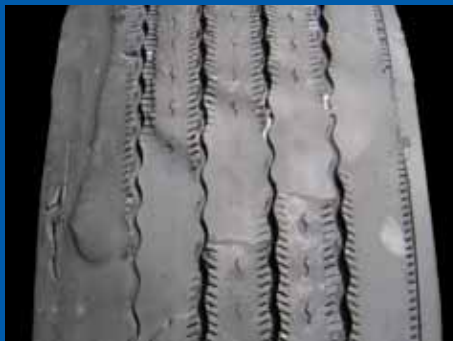
Diagonal Wear

Appearance	Manifests in the form of oblique wear patches. Can appear singularly or repeat around the circumference of the tire.
Probable Cause	Misalignment, radial and lateral runout, severe out of balance, loose wheel bearings or steering parts.
Corrective Action	Check for mismatch and worn parts.
Tire Disposition	Reverse direction of tire or retread.

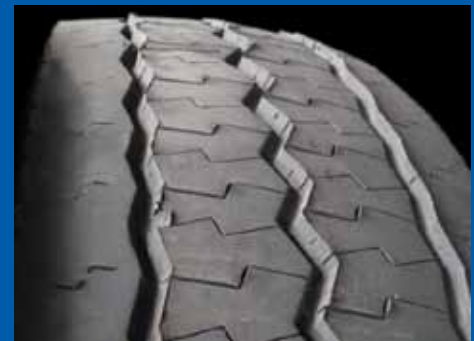
Radial Feather Wear

Appearance	Feathering at the edge of the tread ribs.
Probable Cause	Usually the result of continued exposure to lateral force, such as excessive toe. Can also form as a result of counter-steering to compensate for drive axle misalignment.
Corrective Action	Check alignment.
Tire Disposition	Rotate to another position or retread.

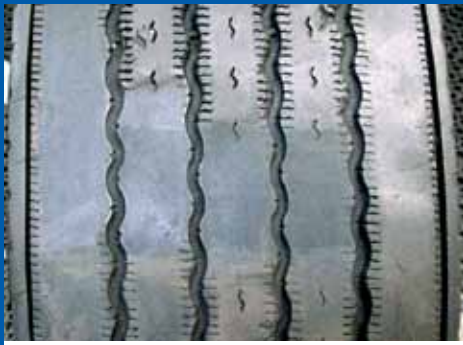
Multiple Flat Spotting Wear

Appearance	Multiple radially worn areas around the tire.
Probable Cause	Faulty shocks, loose/worn wheel bearings, severe balance issues, mismatched pressures or tire diameters, excessive high speed empty operation.
Corrective Action	Check for mechanical issue, check air pressure.
Tire Disposition	Continue to run or retread.

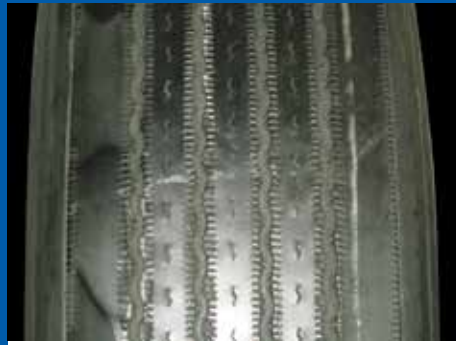
Depression Wear (Shoulder)

Appearance	Localized wear patch on the shoulder rib of the tire. This patch can repeat around the circumference of the tire.
Probable Cause	Faulty shocks, lateral runout, loose wheel bearings, mis-mount, severe balance issue.
Corrective Action	Check for mechanical problem.
Tire Disposition	Continue to run, rotate or retread.

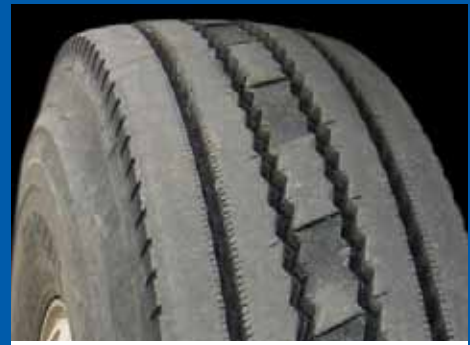
Depression Wear (Center)

Appearance	Circumferential depression wear of the center tread rib.
Probable Cause	Overloaded/underinflated, faulty shocks, loose wheel bearings, mismatch, high speed empty haul conditions.
Corrective Action	Check air pressures/load weight and worn parts.
Tire Disposition	Continue to run, rotate or retread.
